Project Profile

Bando USA

Manufacturing company decides to stop using bandage approach to fixing roof leaks.

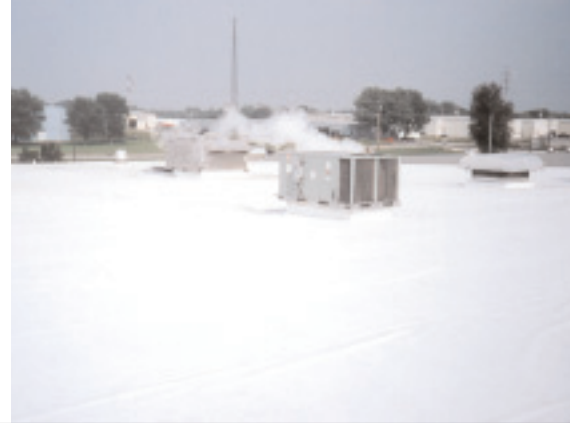
Bando USA's standing seam metal roof had been leaking and causing production problems since it was constructed in 1988. Extensive repairs were made over the years by stripping in horizontal lap seams and flashing transitions. These repairs had varied degrees of success.

The surface of the metal roof was made flat by installing miter-cut "fill" insulation strips and then a continuous overlay of insulation. A white, reinforced thermoplastic membrane was then applied and mechanically fastened to the metal roof. The thermoplastic membrane was joined to itself by hot air welding, eliminating the possibility of leaks at the seams, which were so troublesome for 15 years.

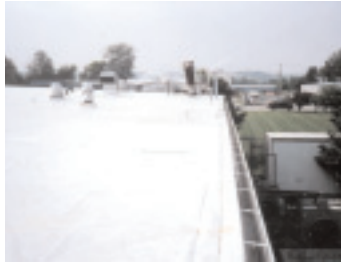
Flexible membranes.

The flexibility and formability of thermoplastic membranes can eliminate troublesome pitch pans. The white color of the thermoplastic membrane reduces solar loading and saves energy in the air conditioned office.

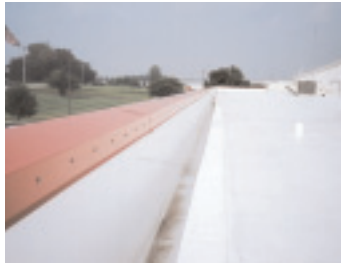
Exterior gutters.

The exterior gutter was replaced to prevent water from backing up under the metal panel roof during very heavy rain.

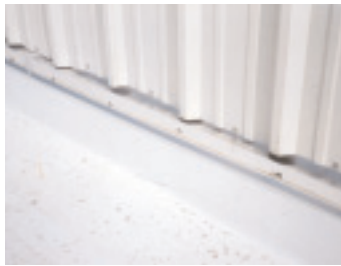
Interior gutters.

Interior gutters at walls or valley lines of metal roof systems are often problematic. At the office front parapet, the walls were faced with plywood, roofing membrane was used to line the gutter and wrap the wall, and an attractive pre-finished metal cap finished the detail.
