Project Profile

Protecting roof structure and improving maintenance at grain milling facility.

**Bunge Milling
Atchison, Kansas**

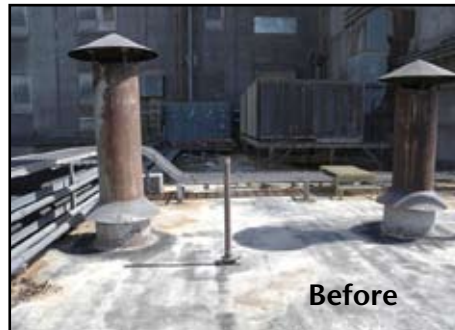
The old built-up roof was difficult to maintain and allowed ponding water to infiltrate into the insulation and concrete decking – threatening the building structure and operations at the milling facility.

The previous built-up roofing system at Bunge Milling had very little slope and was not designed to prevent standing water from entering the roof system. Heavy roof traffic, multiple penetrations, and inadequate flashings allowed water to enter the roof system and deteriorate the roof insulation.

The uneven roof surface and multiple penetrations with low clearances also made it impossible to thoroughly clean corn flour from the roof.

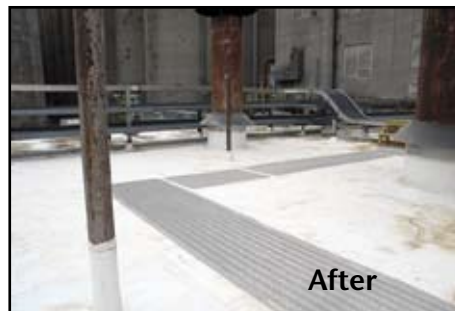
The new roof features a smooth TPO surface and additional clearance under penetrations to allow easier and more complete cleanup of corn material that accumulates on the roof. A hot-air welded walkway was installed to prevent wear and damage from mill worker traffic.

D. C. Taylor Co. removed several inches of cracked built-up roofing and wet insulation. The D. C. Taylor Co. crew allowed the concrete deck to dry before installing heavy-duty 80-mil FleeceBACK® TPO in water-based bonding adhesive to the concrete deck. This created a smooth, puncture-resistant roof surface that is durable and easy to maintain.

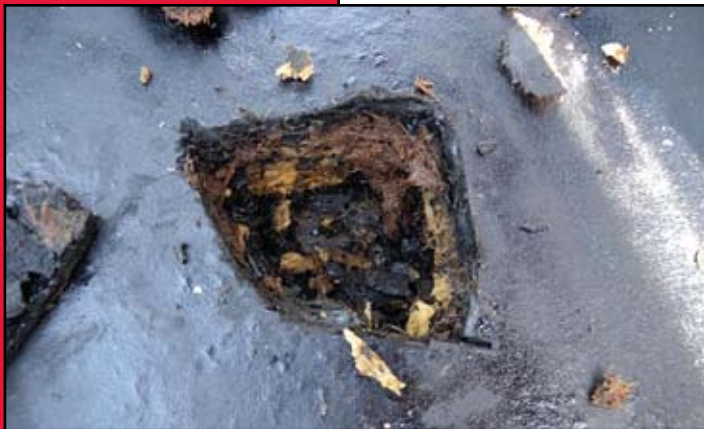
Investigation and Recommendation

Multiple core cuts were taken to determine the extent of moisture infiltration. Water trapped in the roof system and the need for a material that would flash around the unique roof projections led D. C. Taylor Co. to propose tearing everything off down to the concrete deck, and allowing it to dry before installing the new system. A temporary roof had to be installed in some areas to let the concrete dry overnight and to protect the exposed structure.

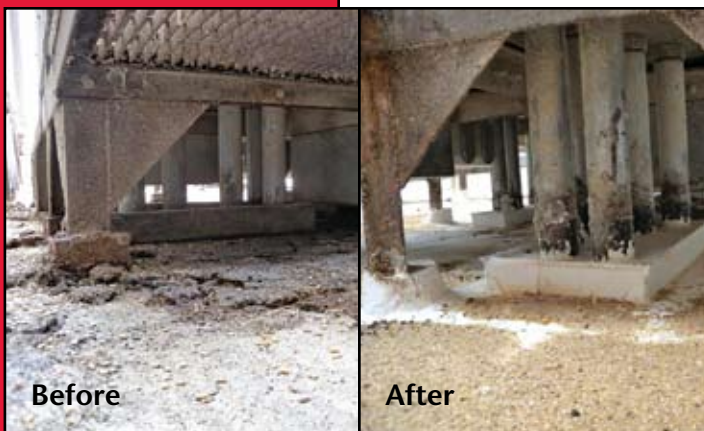
Maintenance Hazard

Many roof projections created low clearances that didn't allow complete cleaning and maintenance of grain material. D. C. Taylor Co. removed nearly 5 inches of built-up roofing material to improve access to these areas. Field formed and pre-fabricated projection flashing were installed on more than 100 angle-iron and pipe penetrations.

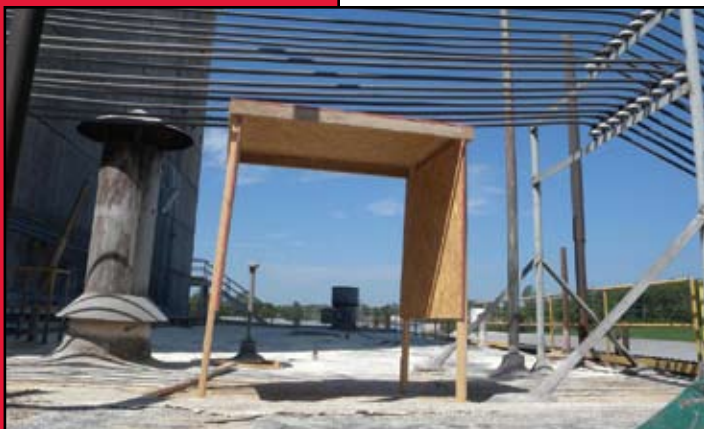
Special Safety Considerations

High-voltage electrical conduits were located in many areas of the roof, including the main access area where they hung approximately 6 ½ feet overhead. Timm Haefner, the D. C. Taylor Co. project superintendent, and Chad Rouse, project foreman designed a special rubber curtain and a plywood tunnel to reduce worker exposure to the electrical lines.
