Project Profile

Graphic Packaging
Centralia, Illinois

Finished Products at Risk at Graphic Packaging Corporation

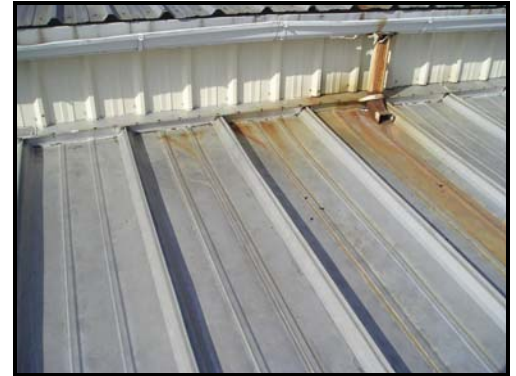
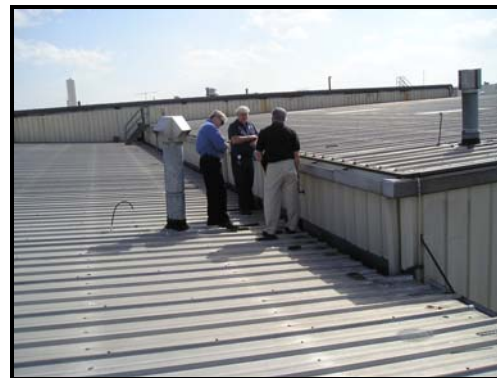
Before

Problem: Leaks in the Pressroom roof were putting valuable equipment and finished products at risk. The existing metal roof had been damaged by frequent HVAC service traffic and was also leaking at roof panel joints and flashing transitions.

Solution: Graphic Packaging determined that the proposal from Ben Fashimpaur, Regional Manager with D. C. Taylor Co. provided them with the best long-term solution to their existing problem. The new thermoplastic (TPO) roof membrane retrofit incorporated insulation over the existing standing seam metal roof to convert the roof into a uniform-flat surface while adding strength and additional "R" value.

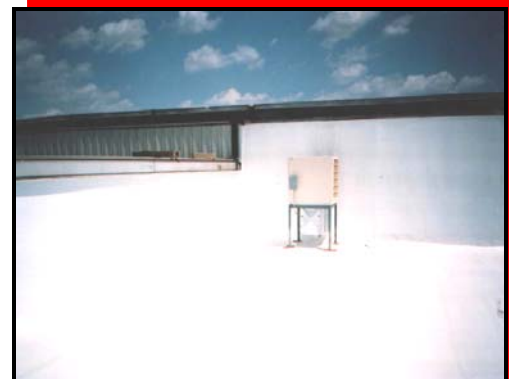
After

Results: The new roof system eliminated the existing points of roof failure and should handle roof traffic better. It has a superior flashing system for curbs and transitions. The white thermoplastic membrane yields 90% ultraviolet reflectivity. This will significantly reduce solar heat gain (lowering cooling costs and increasing energy savings); and, encourages longer material life through reduced ultraviolet degradation on the system. The roof installation was executed without any safety incidents or disruption to the Graphic Packaging's production.
