Georgia-Pacific Tissue Mill

Roofing project by D. C. Taylor Co.

Outstanding workmanship overcomes three unique challenges.

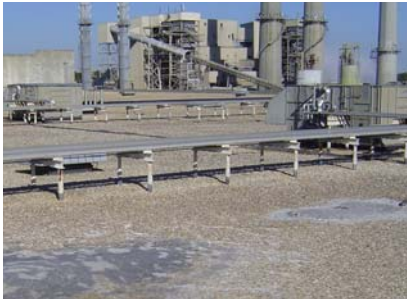
Before roofing work.

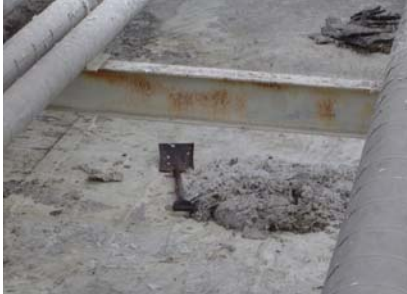
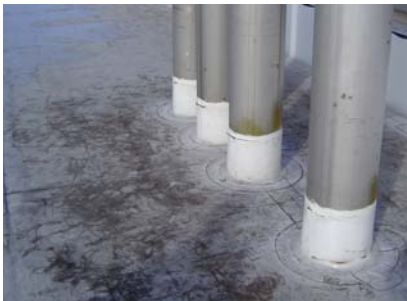
Black discoloration on roofing material is caused by blowing coal dust from nearby coal storage area due to high winds.

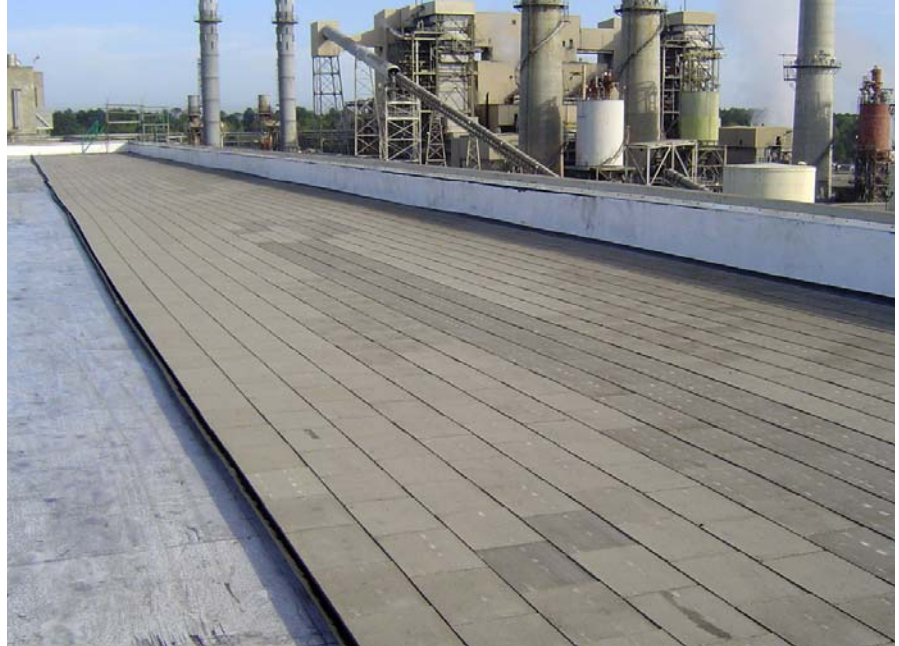
Georgia-Pacific was concerned about wind damaging their new roof. Their facility is unusually tall at 54 feet and is also located in a potential hurricane path. Wind uplift forces are greater at corners and perimeters of the roof.

In addition to the fully adhered system, D. C. Taylor Co. installed interlocking concrete pavers in a 20 foot wide area next to a perimeter wall that faces the ocean winds. This system provides additional resistance to wind uplift pressures.
