Project Profile

D. C. Taylor Co. completes complex roofing project.

Grain Facility

40,000 square foot rain roof
Tacoma, Washington

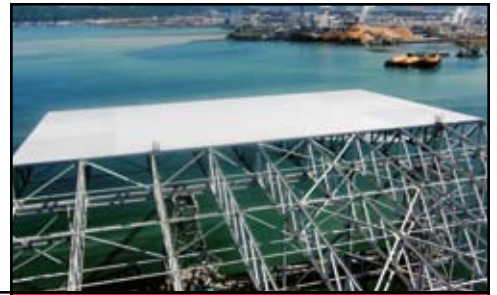
This rain roof allows soybeans and other grain to be loaded into ships during rainy weather.

D. C. Taylor Co. installed a layer of 1" isocyanurate insulation, ½" dens deck barrier board, and 60-mil GAF PVC membrane over the existing metal deck. This simple plan was complicated by a number of factors such as design, permitting, scheduling, loading, and safety.

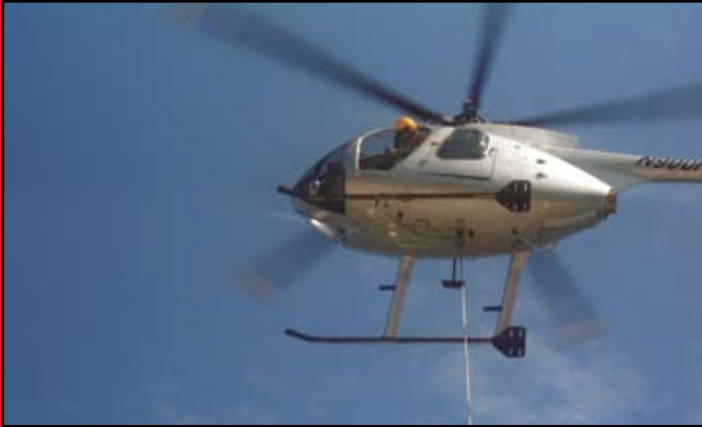
To load materials safely without damaging the roof, the weight of the pallets had to be evenly distributed. A helicopter was the most efficient and safest method to load materials. The materials were laid out on the ground in the exact manner they would be placed on the roof. A total of 142 helicopter lifts were required.
